Lower Swiftwater Creek Sub-Watershed Potential Restoration Sites

Upper Swiftwater Creek Sub-Watershed Potential Restoration Sites

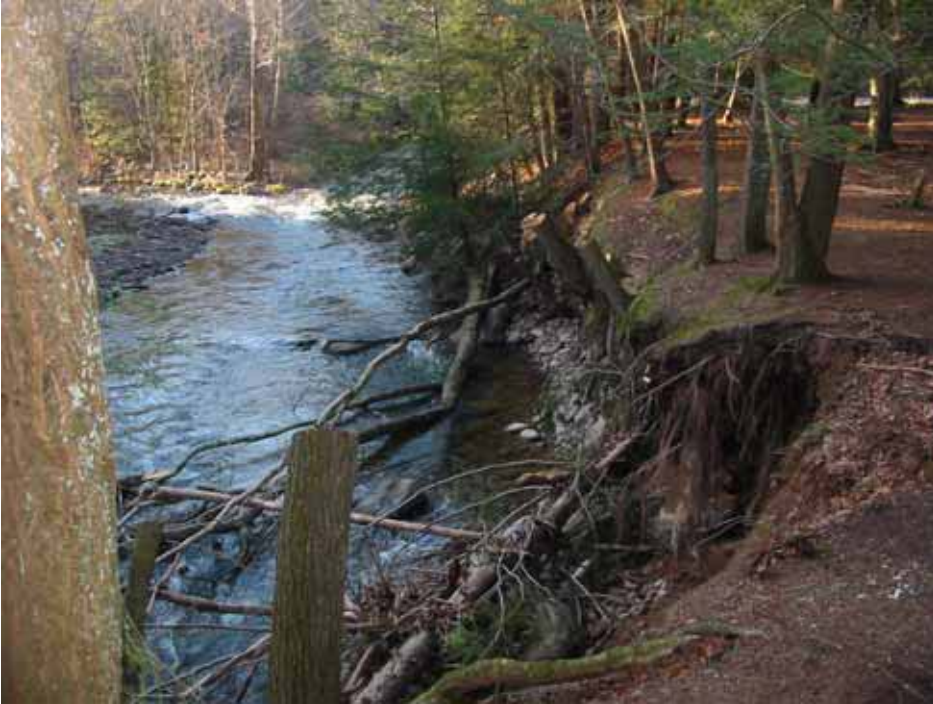
Figure 13: Lower Swiftwater Project 1: Left bank erosion at confluence of Forest Hills Run and Swiftwater Creek. Landowner has received emergency stabilization funding, but post-stabilization habitat improvements and perhaps upstream channel realignment would improve instream conditions. This site was previously channelized, creating a 90-degree confluence of the streams and producing these erosion effects.

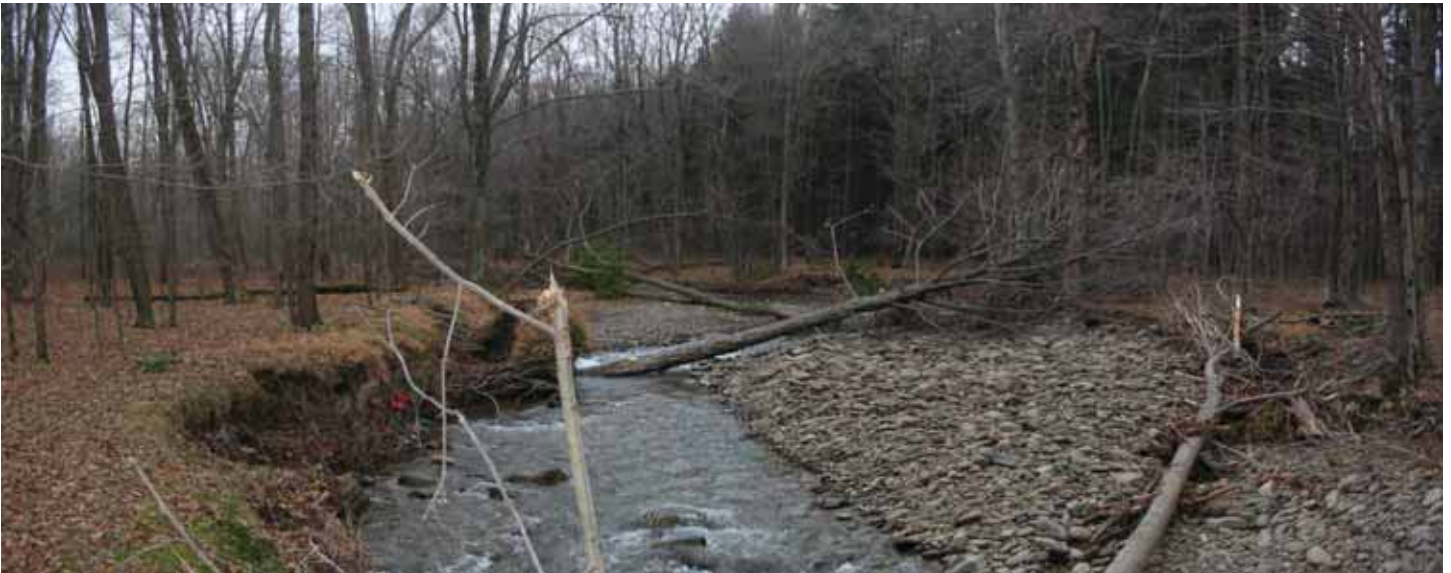
Figure 14 - Lower Swiftwater Project #2: Swiftwater Creek upstream of Route 314 crossing – up to 2 miles of severe erosion.
